## HOME INSPECTION REPORT

11 Mountain Drive

Property Inspection reference number:

JP-smvl-2004-12-03

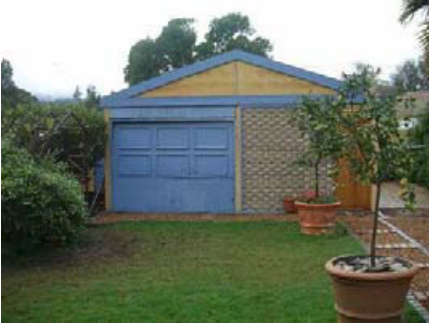
Overall Quality			¿		
		Plugs / wiring		2 Plugs			
		Light switches		2			
		Wall finishing				Paint (D)	
		Floor finishing			Cement		
		Ceiling finishing			Rhino board		
		Doors			¿		
		Windows		¿			
M <sup>2</sup>	75	<b>NOTES</b>	€ Electronic garage door opener which offers direct access to house. € An extra garage door to back of property is also present. € (D) - Crack evident in garage walls- points towards structural defect.

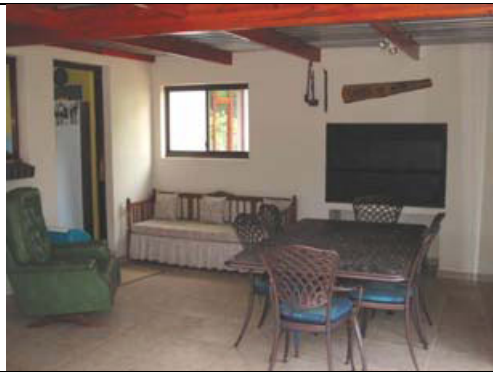
Overall Quality			?			
	Plugs / wiring			2			
	Light switches			1			
	Wall finishing				Paint		
	Floor finishing			Wood			
	Ceiling finishing			Wood			
	Doors			?			
	Windows				?		
<b>M<sup>2</sup></b>	20	<b>NOTES</b>					
<b>Facing</b>	West						
<b>Kitchen</b>			Excellent	Good	Average	Poor	Very Poor

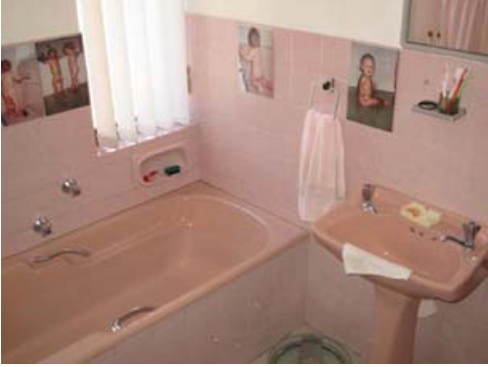
Overall Quality			¿		
	Plugs / wiring		1 plug			
	Light switches	N/A				
	Taps		4			
	Toilet		1			
	Bidet	N/A				
	Bath		1			
	Shower	N/A				
	Wall finishing			Paint/tiles		
	Floor finishing			Tile		
	Ceiling finishing					Rhino board (D)
	Doors			¿		
	Windows			¿		
<b>M<sup>2</sup></b>	15	<b>NOTES</b> ≠ (D) - Defect noted regarding the ceiling.				
<b>Facing</b>	West

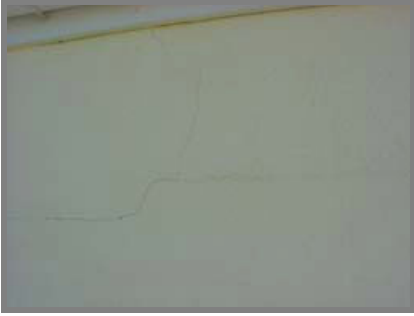
<b>Defect(s) Assessment</b>			
<b>Garage</b>	<b>Description of defect(s)</b>	<b>¿ MINOR</b>	<b>¿ MAJOR</b>

Cracks evident- indicating structural problems.		¿
<b>Pool</b>

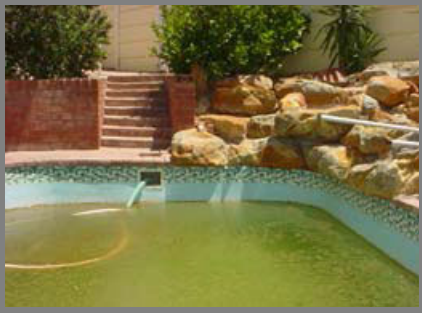
Pool				Excellent	Good	Average	Poor	Very Poor
 			Overall Quality			¿		
			Pool Structure					¿(D)
			Paving			¿		
			Pump & filter system		¿			
Pool net?	Y	N	<b>NOTES</b>	≠ (D) – Water level shows sagging pool.				
Pool fence?	Y	N						
Laundry room				Excellent	Good	Average	Poor	Very Poor
 			Overall Quality			¿		
			Plugs / wiring		2			
			Light switches		1			
			Wall finishing			Paint/tiles		
			Floor finishing			Tiled		
			Ceiling finishing		Rhino board			
			Doors		¿			
			Windows		¿			
M <sup>2</sup>	15		<b>NOTES</b>					
Facing	West

Damaged swimming pool (water level shows sagging pool structure)	¿	
<b>Bathroom in Granny Flat</b>

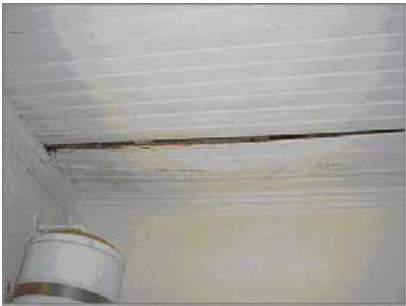
Sagging and water damage to ceiling	¿
