## HOME INSPECTION REPORT

11 Mountain Drive

Property Inspection reference number:

JP-smvl-2004-12-03

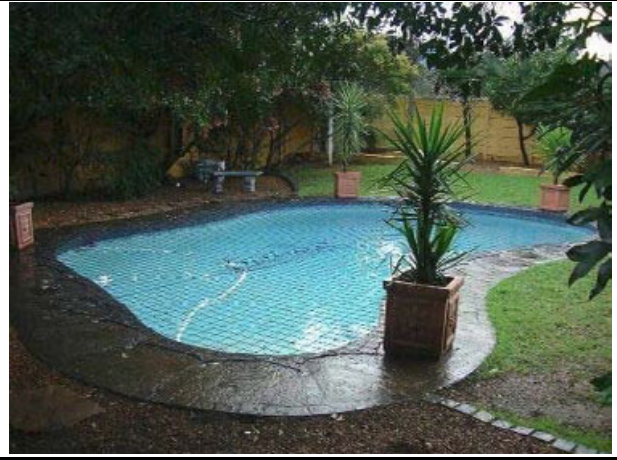
Pool

Damaged swimming pool (water level shows sagging pool structure)	¿	
<b>Bathroom in Granny Flat</b>

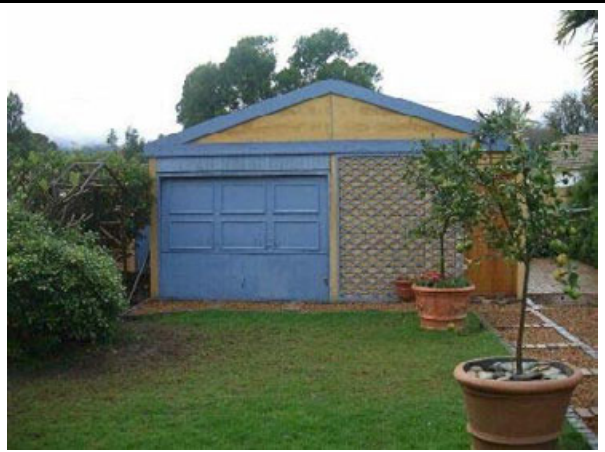
Garage

Overall Quality			¿		
		Plugs / wiring		2 Plugs			
		Light switches		2			
		Wall finishing				Paint (D)	
		Floor finishing			Cement		
		Ceiling finishing			Rhino board		
		Doors			¿		
		Windows		¿			
M <sup>2</sup>	75	<b>NOTES</b>	€ Electronic garage door opener which offers direct access to house. € An extra garage door to back of property is also present. € (D) - Crack evident in garage walls- points towards structural defect.

Cracks evident- indicating structural problems.		¿
<b>Pool</b>
